PROPERTY SURVEYING SERVICES

Customer Detail	
Clients Name	XXXXXXXXXXXXXXXXXXXX
Address	XXXXXXXXXXXXXXXXXXXX
Survey Type	Damp
Report Reference	GL380007
Inspection Date	12/03/2020
Surveyor Name	Graham Eaton
Conditions	Dry/Overcast

Thank you for instructing us to carry out a damp and timber survey of the ground floor. We understand that you own the house and that your buyer's Homebuyers Report highlighted potential areas of damp. Please inform us if we have misunderstanding your instructions.

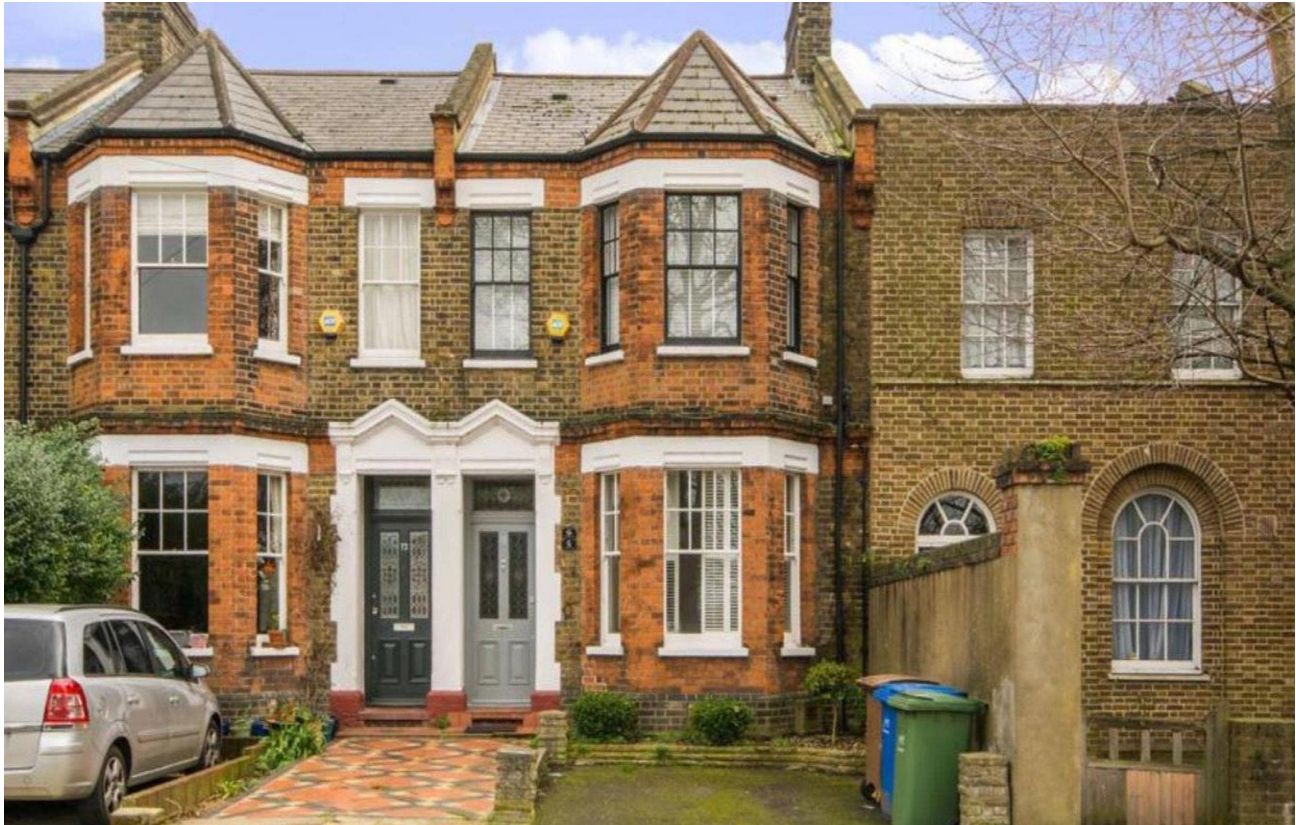
There tell-tale signs that a chemical damp proof course is already in place. The round ridges highlighted in the photo above, cover drill holes used to inject chemicals. Chemical damp proof courses rarely address the cause of damp. In this case the cause of marginal dampness deep within the wall is inexpensive to fix.
